SUBJECT: Illinois/Eckhardt Report

Mendota/Trekker Chemical Co.

Introduction

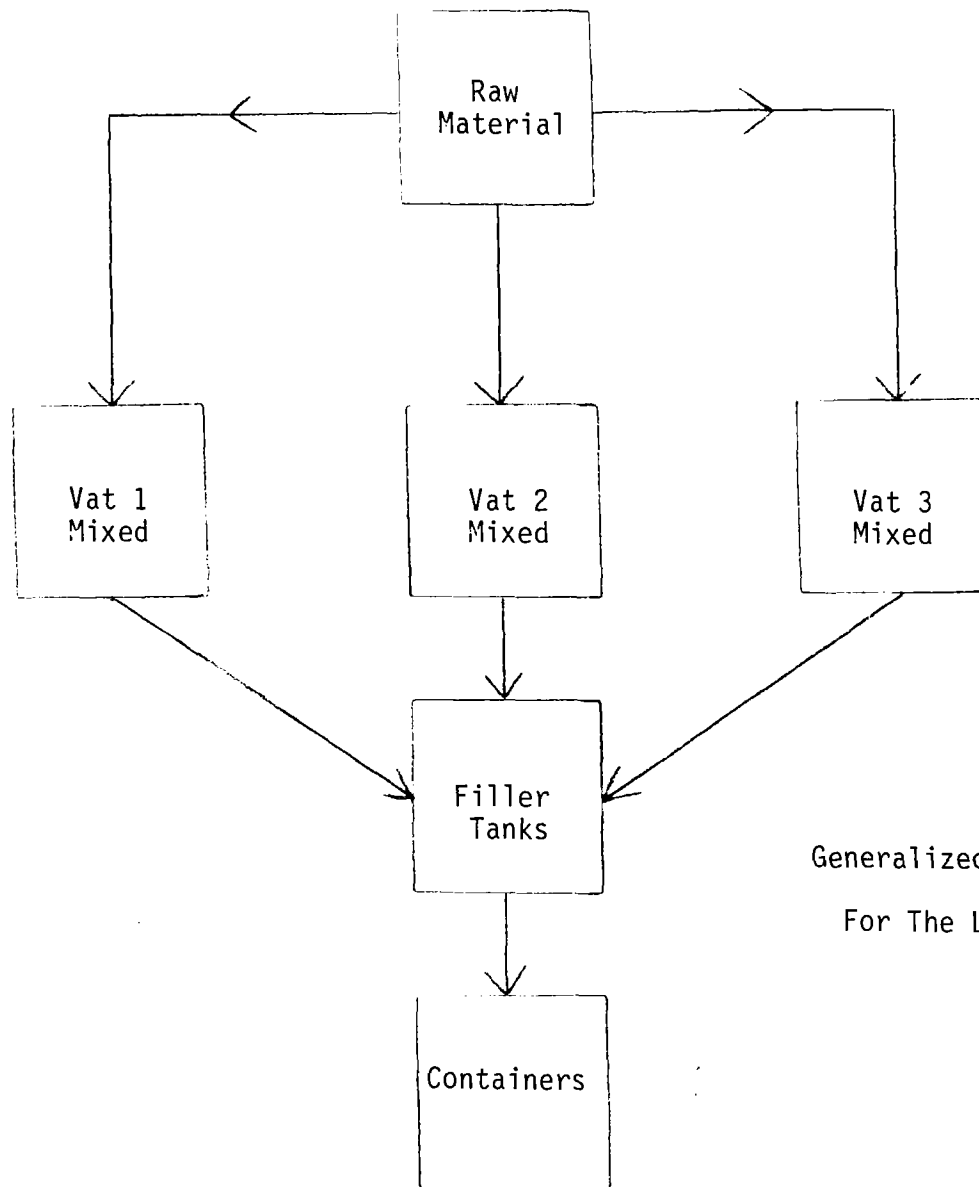
Figure 1
Generalized Process Flow Chart
For The Liquid Department

Following the blending period, each vat has the capacity to be pumped individually to one of three stainless steel filler tanks. Depending upon the type of container that is to be filled, will dictate which filler tank this material is pumped into (see Figure 1).

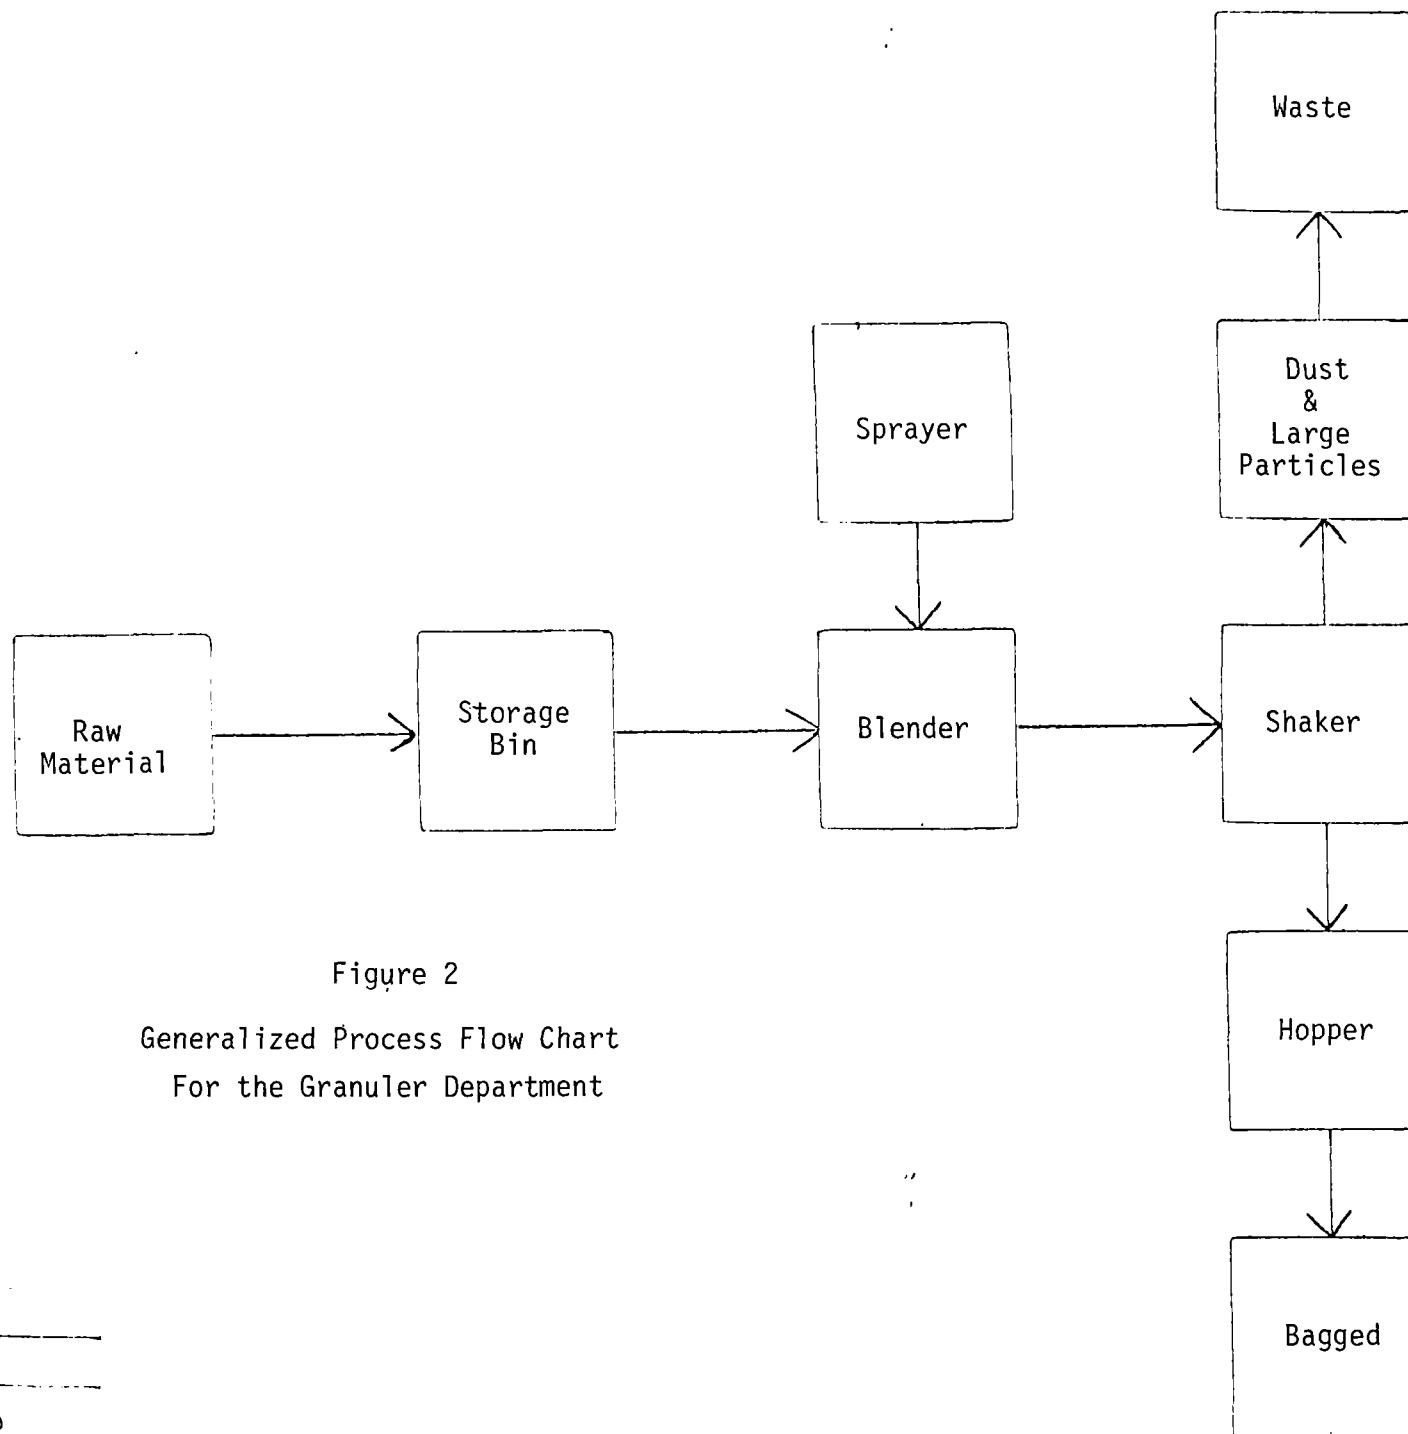
Figure 2
Generalized Process Flow Chart
For the Granuler Department

Clay from the state of Georgia is received by the company via railroad cars. The clay is stored within a number of bins located outside of the plant. When needed, the clay is transferred from the bins to an enclosed blender inside the plant. As the blender rotates, a set of nozzels connected to the blender spray the clay particles inside with either of the previous mentioned chemicals from the Granular Department. After the clay has been sprayed, the material proceeds to a shaker which separates unwanted dust and large size clay particles. The material is then sent (elevated) to a hopper where this material is bagged (see Figure 2). The dust and large size particles, considered a hazardous waste is drummed and hauled by the company to a licensed landfill.
